## Detection and Minimizing of Surface Blistering in Continuously Cast and Hot-Rolled Mild Steel Coils

This study investigates the root courses of surface blistering and explores methods to minimise it in hot-rolled coil steels containing 0.1–0.2 C, 0.4–1.6 Mn, 0.05 Si (wt.%). Surface voids are believed to form during continuous casting, to develop into surface cracks during hot rolling, and to result in product rejection. These defects are found in the central part of the coils on the side corresponding to the small radius of the continuous casting machine (CCM). Metallographic analysis of samples reveals the defect-proliferation

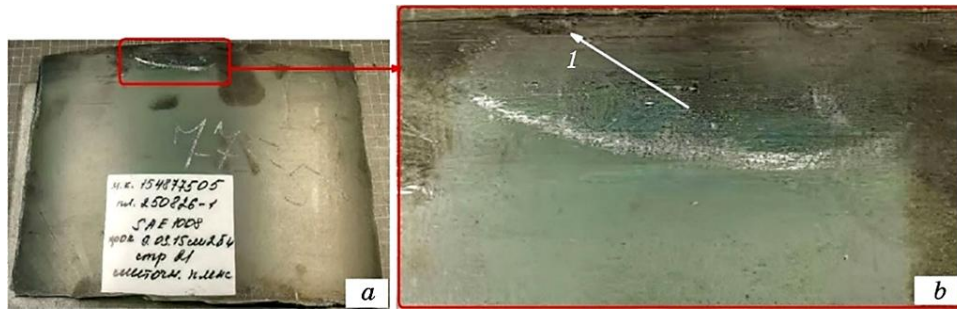
**Fig. 1.** Photoimage of sample No. 1 (SAE 1008 steel) with a blister (1) defect on the edge (a) and its enlarged view, revealing delamination (b).

ering a 10 mm wide zone (Fig. 1). Directly along the edge, two small 10–15 mm long delamination were found. On sample No. 2 (Fig. 2, a), the entire surface of the rolled product is affected by blisters (Fig. 2, b). Small delamination has also been found extending along the rolling direction up to 20 mm long, accompanied by a dark haze (Fig. 2, c). On sample No. 3, the entire surface is affected by small delamination accompanied by a dark haze (Fig. 3). On this sample, the defects are located on one rolled surface.

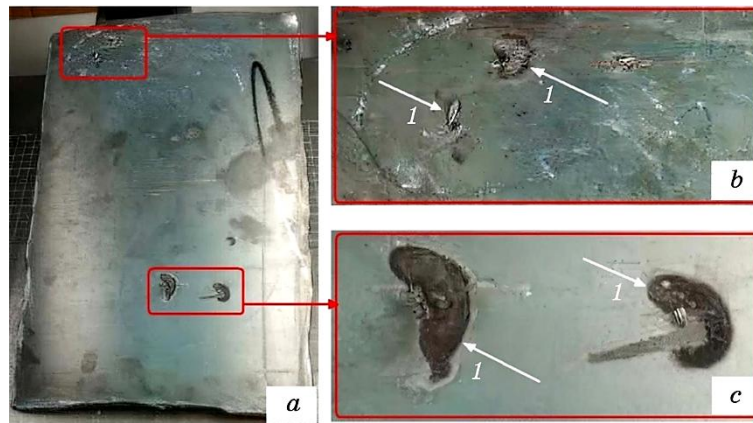
**Fig. 2.** Photoimage of sample No. 2 (SAE 1008 steel) with blister (1) defects (a), affected area (enlarged) (b), and delamination (enlarged) (c).

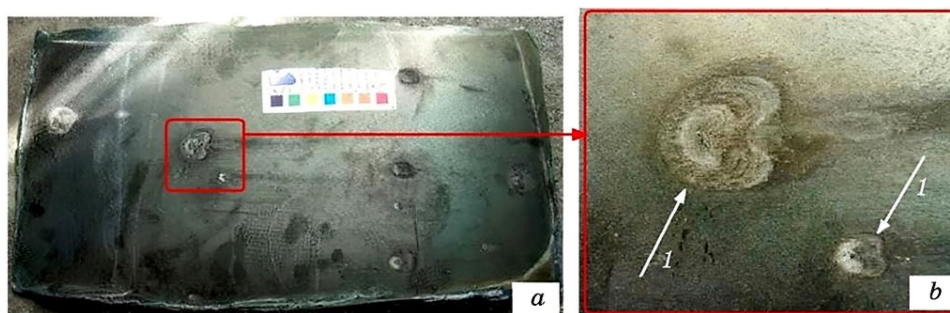
**Fig. 3.** Photoimage of sample No. 3 (steel S235) with a blister (1) defect (a) and delamination (enlarged) (b).

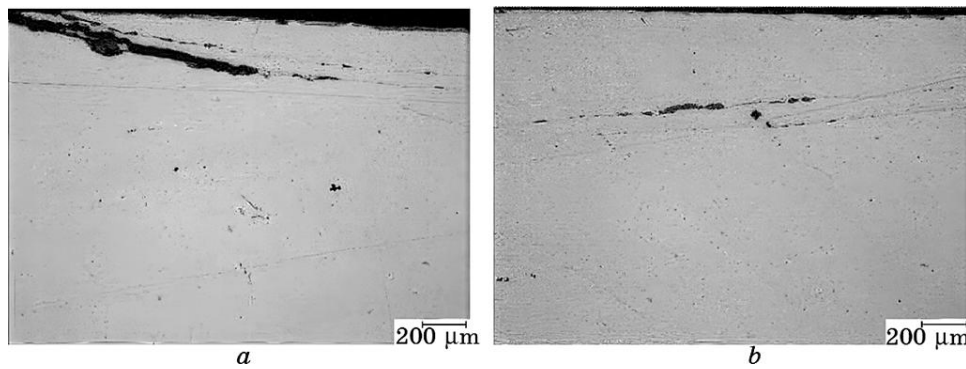
The macrostructure of a delamination in steel SAE 1008 is shown in Fig. 4, *a*. A coarse cluster of iron oxides was revealed in the delamination cavity. The thickness of delamination was of 80–200  $\mu\text{m}$ . The delaminated metal is diffusively oxidized, completely decarburized; the ferrite grain is enlarged to number 6–7 (32–45  $\mu\text{m}$ ). The depth of the decarburized layer at the defect site was measured to be of 100–300  $\mu\text{m}$  (Fig. 4, *b*). The delamination walls with a haze had a thickness of 26–70  $\mu\text{m}$ . The delamination cavity was oxidized, accompanied by oxide accumulations. The exfoliated metal was diffusively oxidized, completely decarburized; the ferrite grain was enlarged to number 6–7 (32–45  $\mu\text{m}$ ). The depth of the decarburized layer was of 100–234  $\mu\text{m}$ .

Blisters revealed on samples Nos. 1 and 2 had a structure similar to delamination (Figs. 4 and 5). In line with oxide accumulations, the metal was decarburized in sample No. 1 to a depth of 275  $\mu\text{m}$ , and in sample No. 2—to 296  $\mu\text{m}$  (Fig. 5, *b*). The ferrite-grain size increased to the number 6–7 (32–45  $\mu\text{m}$ ). In areas not affected by defects, the de-

**Fig. 4.** The macrostructure of the walls of delamination (*a*) and blisters (*b*) in sample No. 1 (magnification  $\times 50$ ).

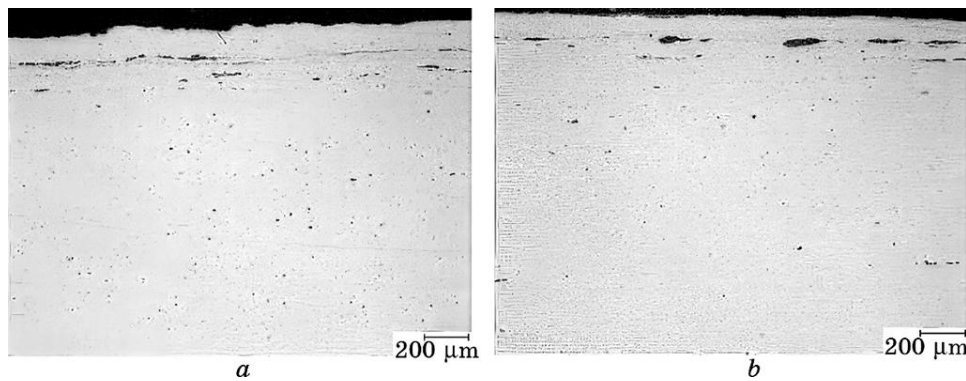
**Fig. 5.** The macrostructure of the blister walls in sample No. 2 (magnification  $\times 50$ ).

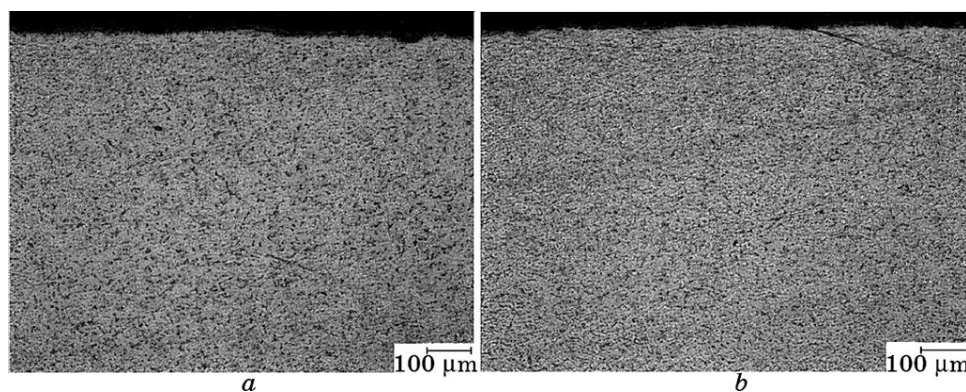
carburized surface of the rolled product was absent on both samples (Figs. 6 and 7). The ferrite-grain number was 9–10 (11–16  $\mu\text{m}$ ).

**Fig. 6.** Microstructure of sample No. 1 through rolled-metal thickness (magnification  $\times 100$ ).

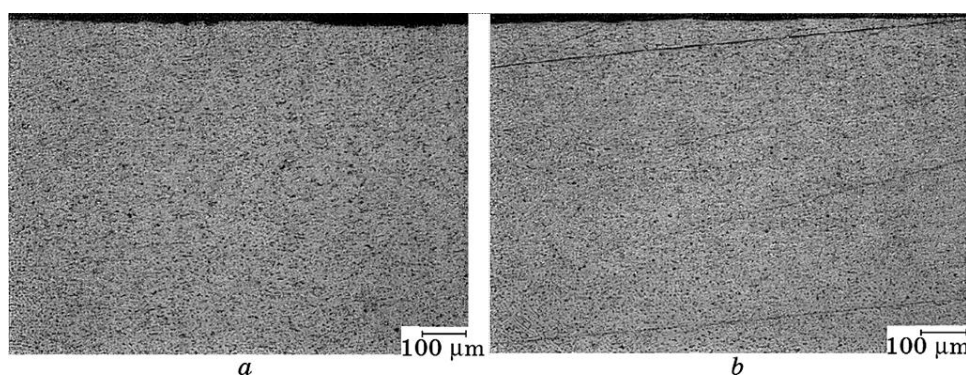
**Fig. 7.** Microstructure of sample No. 2 through rolled-metal thickness (magnification  $\times 100$ ).

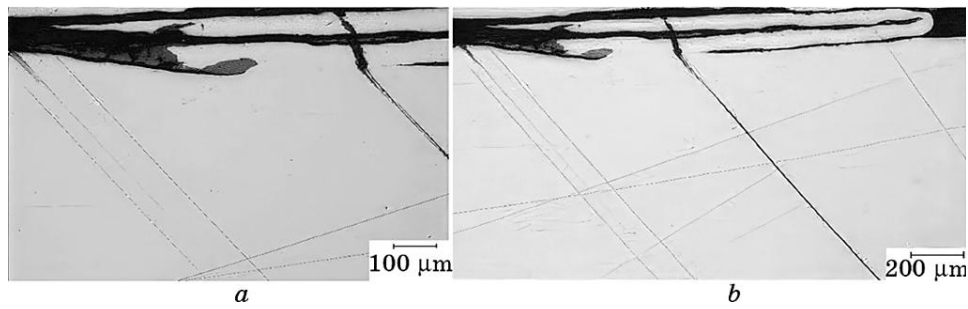
The macrostructure of the delamination walls with a haze in steel S235 is shown in Fig. 8. There are no clusters of non-metallic inclusions along the walls of the delamination. Clusters of iron oxides were found in the root of the delamination and along its length. The thickness of the delamination was of 11–50  $\mu\text{m}$ . The delaminated metal was diffusively oxidized, partially decarburized; the ferrite-grain size was

Fig. 8. Microstructure of delamination walls in sample No. 3 (magnification  $\times 100$  (a), magnification  $\times 200$  (b)).

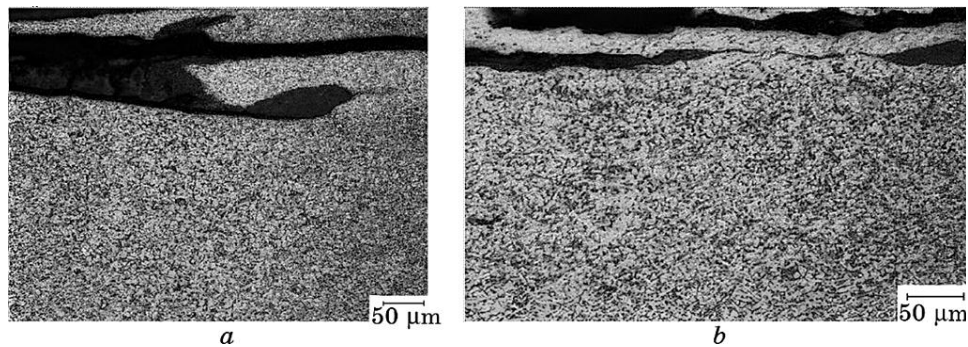
slightly coarsened to the number 8 ( $22\text{ }\mu\text{m}$ ). The depth of the decarburized layer at the defect site was up to  $20\text{ }\mu\text{m}$  (Fig. 9). In areas not affected by defects, there is no decarburization of the rolled-product surface. The ferrite-grain size number was of 9–10 ( $11\text{--}16\text{ }\mu\text{m}$ ). The results of the study indicate that defects in the rolled products of steel S235 (sample No. 3) were formed during the rolling of oxidized subcutaneous blowholes in continuously cast slab. As for samples Nos. 1 and 2, the absence of decarburization and grain coarsening on the surface of the rolled products away from the defects indicates the absence of metal overheating.

Fig. 9. Microstructure of delamination walls in sample No. 3 (magnification  $\times 200$ ).

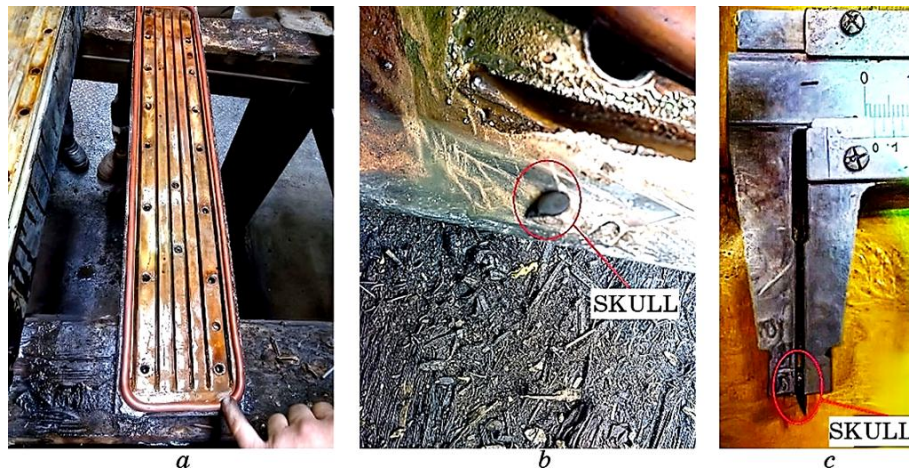
Fig. 10. Photo of the mould wall (*a*) and the skull (*b*, *c*).

(b) on the narrow wall between the steel and water-cooled copper wall on the narrow side (far end), where a water leak was detected, a metal skull was found, and a dent corresponding in shape to the skull was also found (Fig. 10);

Therefore, it can be concluded that the leak in the cooling system was caused by the presence of a metal skull between the steel and water-cooled copper walls of the mould that led to the damage of the seal. Pressure testing (10 atmospheres, 15 minutes) of the copper plates before commissioning did not reveal any defects, but, during the operation of the mould, this defect appeared. This is confirmed by the detection of a dent and a water leak and corresponds to previously obtained results.

methods for prevention of blisters on the rolled steel surface: perform tests of incoming AM- and AF-coals, which are used for carbon-restoration treatment of steel, for water, ash and volatile contents, eliminate the possibility of mixing coals of the AM- and AF-grades with non-coking energy coal during storage, drying and other technological operations, eliminate the possibility of using solid-slag mixtures during steel tapping from the BOF with a shelf life of more than 24 hours, eliminate the production of steel grades, which are going by 'warm' charge to HRM-1700, on BOFs with leaking boiler, use wet ferroalloys only after calcination, conduct mandatory oxidation measurements on the LRU for low-silicon (semi-killed) steel grades cast on continuous casting machines, perform moulds' monitoring for leaks during acceptance and installation on the continuous casting machine, test each batch of mould powder for water content with an increased number of samples (2 or more), conduct weekly monitoring of argon supplied to the continuous casting machine for water content, eliminate using tundishes with violation of the heating and drying schedule.
